Closure Report COASTAL SYSTEMS STATION FUEL PIPELINE CLOSURE CONTRACT NO. N61331 - 01 - M - 3737

INTRODUCTION: Coastal System Station (CSS) is located on US Highway 98 in Panama City, Florida.

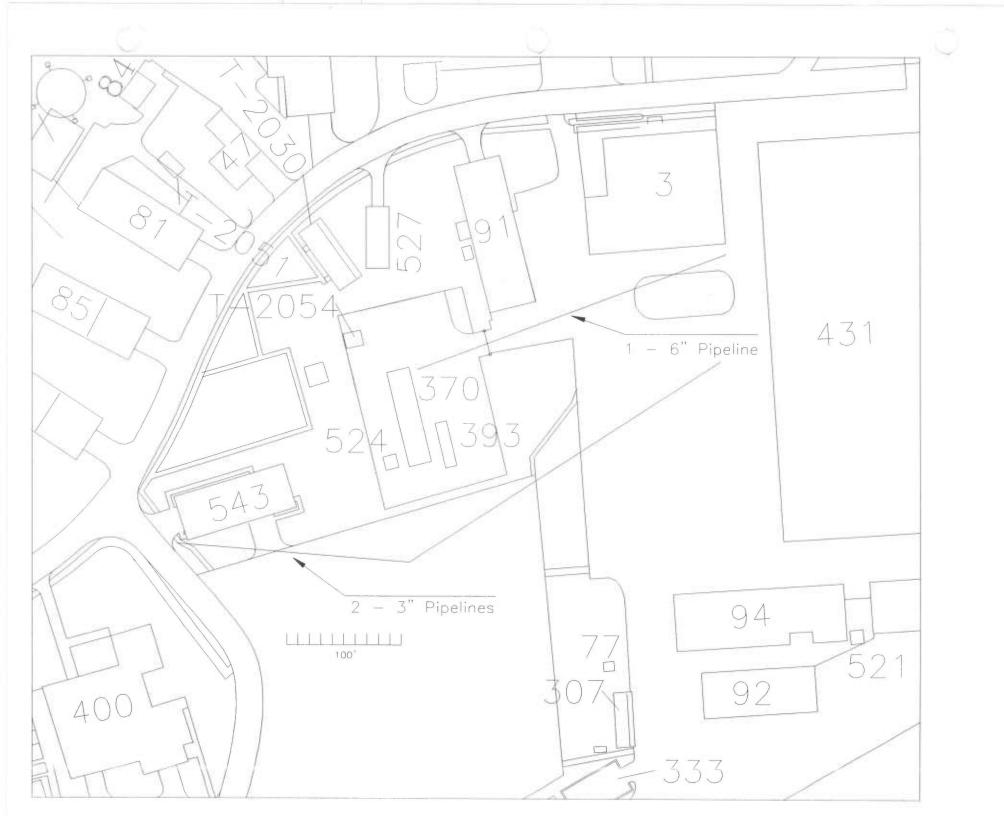
A diagram is included with this report to show the location of the 6" pipeline and the location of the double 3" pipelines. While sampling is required on closure activities, it was not included within the FSRC contracted scope of work.
